Armour Restoration

CASE STUDY: Crystalline Concrete Waterproofing

CASE STUDY: Exterior Masonry Repairs

CASE STUDY: Leaking Condominium Balcony Doors

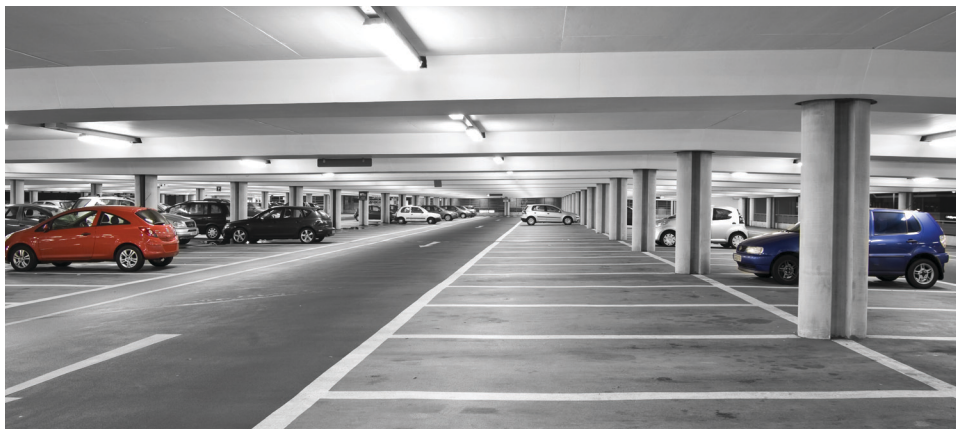
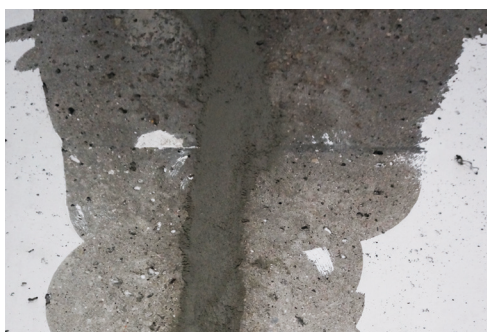
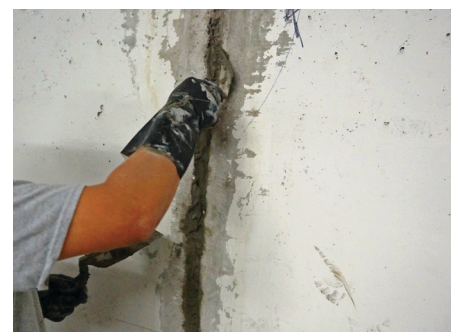
- ▶ An expansive underground garage, underneath two separate condominium towers, had extensive water penetration issues due to water entering through the concrete slab ceiling and walls.
- ▶ Parts of the garage were undergoing exterior slab waterproofing.
- ▶ Major cracks in the concrete were identified in the soffit and walls, which contributed to the leaks.
- ▶ The client requested Armour Restoration to prepare polyurethane injections to seal the interior cracks.

- ▶ Armour Restoration recommended *Kryton*, a crystalline waterproofing technology for concrete repair and waterproofing.
- ▶ Over 1000 linear feet of concrete cracks were chipped out, cleaned and prepared for the *Kryton* application.
- ▶ *Kryton*'s crystalline system was applied in a 4-stage process to repair the cracks, and to stop water leaks.

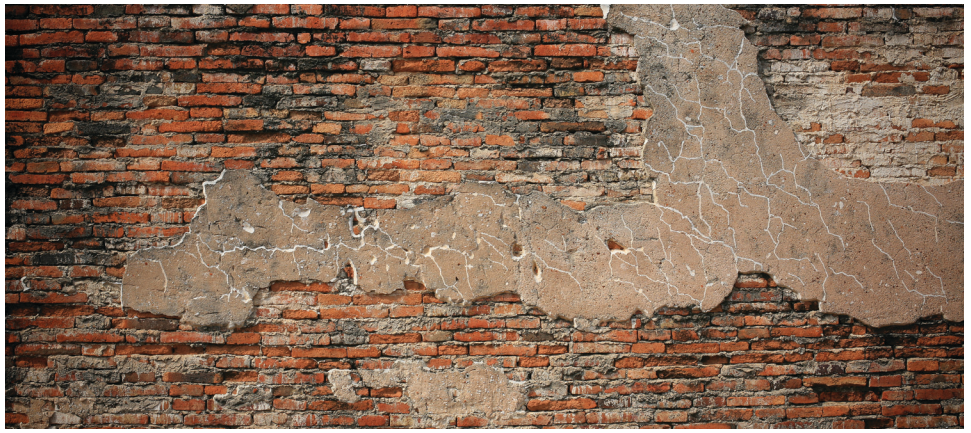
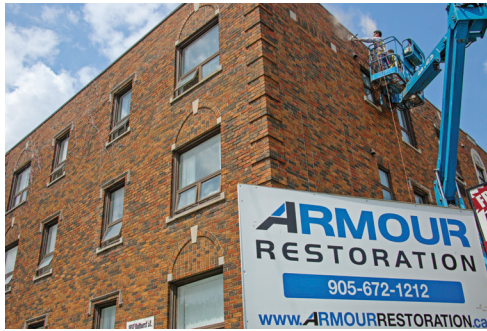
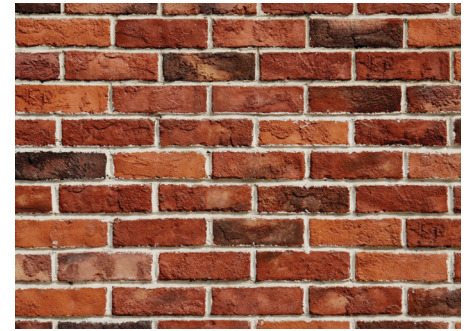
- ▶ This property exhibited major deterioration such as brick spalling and cracked mortar along its upper perimeter, and surrounding windows in various locations.
- ▶ The building envelope was susceptible to water penetration, falling brick, and mortar, as well as degradation of the building's aesthetics.
- ▶ The property was a great candidate for *Dow Corning® AllGuard* waterproof coating, once the bricks were repaired.

- ▶ Armour Restoration performed extensive tuck pointing and brick replacement to match the historic architecture of the building.

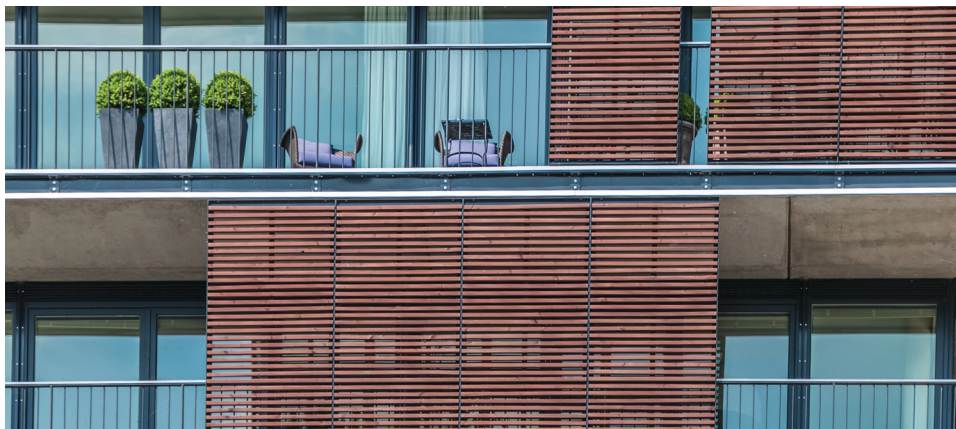
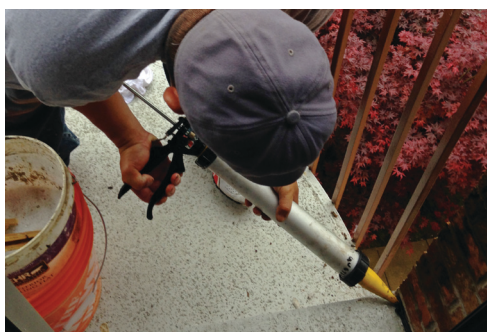
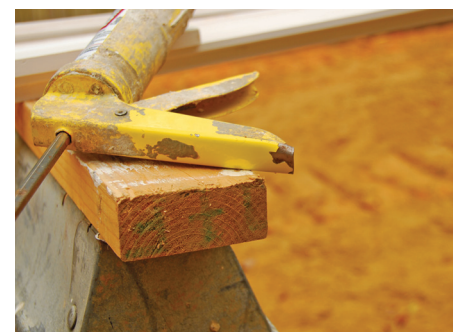
- ▶ The building envelope was compromised with water leaking into the condominium units around the balcony doors, during heavy rain storms.
- ▶ The existing polyurethane caulking had become ineffective due to improper application, age, and its poor quality. Degradation was especially noted on southern exposures because of the sun.
- ▶ The building also exhibited deteriorated bricks and mortar in areas most exposed to the elements. This further compromised the integrity of the building envelope and its aesthetics.

- ▶ Armour Restoration removed the deteriorated caulking. A specific, high quality silicone sealant was installed for its durability and superior properties.
- ▶ We also matched mortar colours and bricks to perform tuck pointing and brick replacement on the building exterior.

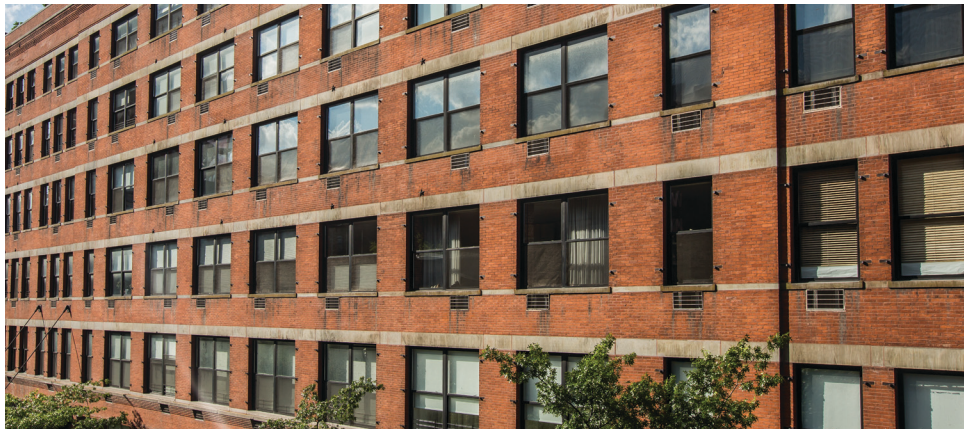
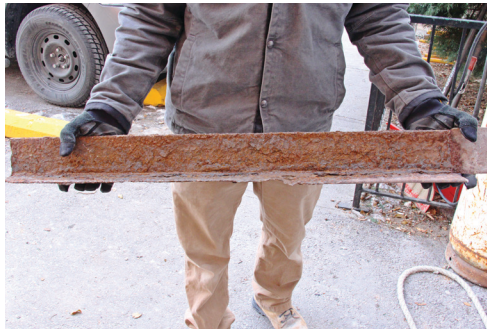
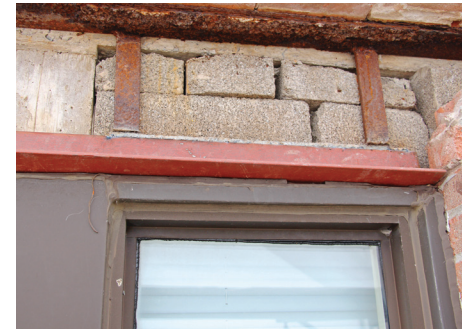
- ▶ The bricks and window lintels were deteriorated owing to poor design, a lack of drainage holes/rain screen, and as well a lack of waterproofing.
- ▶ Water was leaking through the building windows, into the apartment units, as well as around the window frames and balcony doors.
- ▶ The window lintels were undersized and badly rusted. They were also sagging which led to bowing and buckling of the bricks above.

- ▶ Armour Restoration removed the damaged courses of brick on, and above, the window lintels and removed the rusted lintels.
- ▶ Custom, large gauge window lintels were installed with a rust inhibitor and drainage holes to prevent pooling of water.
- ▶ Armour Restoration installed a *Blueskin* waterproof membrane before re-laying matching bricks.

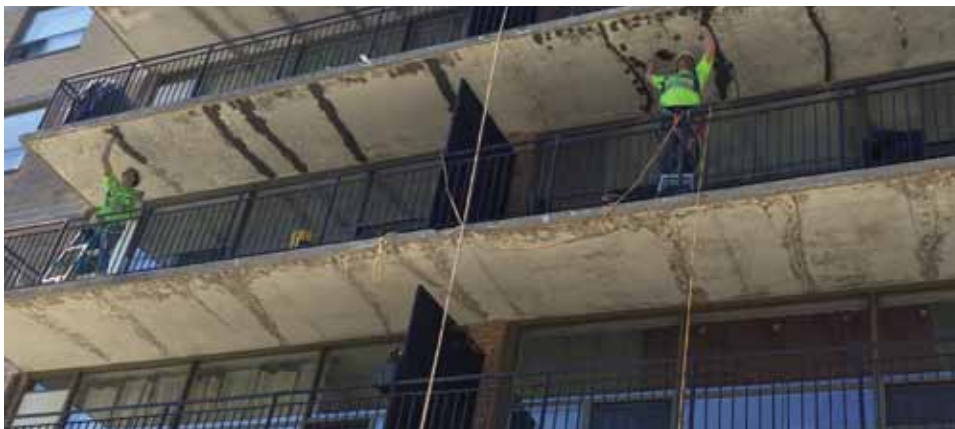
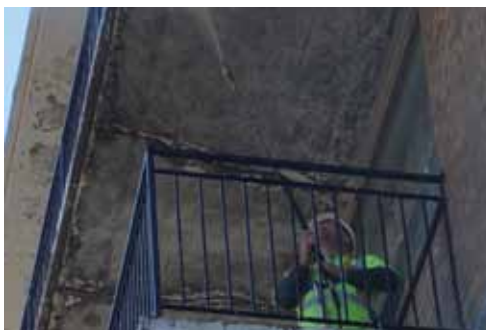
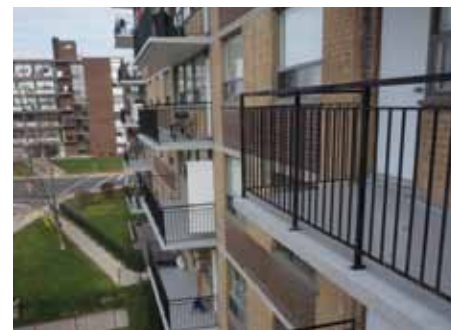
- ▶ Armour Restoration was called on site to perform an inspection of all 50 balconies at 45 Gulliver Road.
- ▶ The balconies were badly deteriorated given the building's age and exposure to Toronto's harsh climate.
- ▶ The concrete slabs were badly deteriorated, with unsightly layers of chipping and peeling paint on the soffits.

- ▶ We began by removing all existing coatings and paints from the concrete slabs. The key to this job was ensuring quality prep work — all old material needed to be stripped completely and cleanly with a 4500 PSI power washer. The slabs were then resurfaced with hydraulic cement.
- ▶ Two coats of urethane coating with rubber aggregate were applied to the balcony floors.
- ▶ We painted the soffits with high-grade exterior paint and painted the railings with DTM paint.

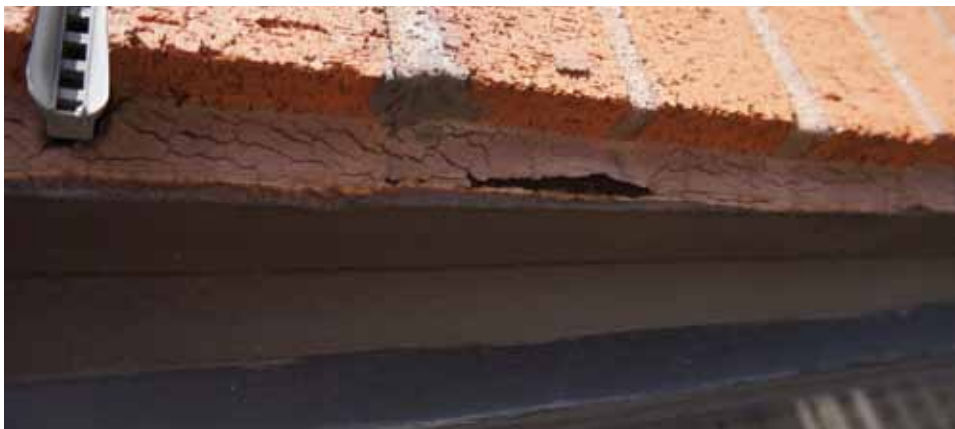
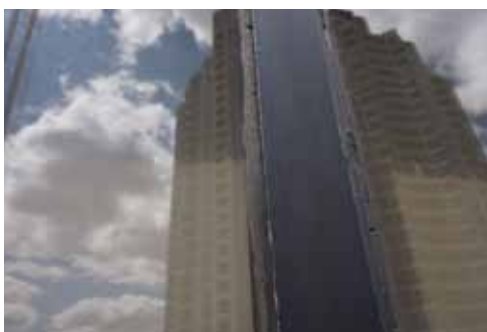
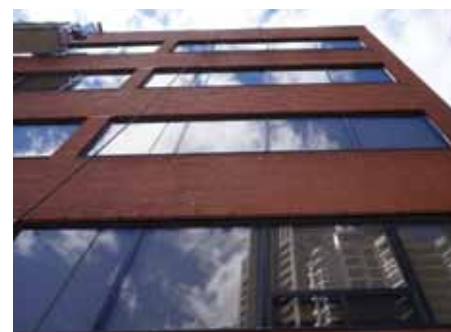
- ▶ The Operations Department at Field Gate Properties was receiving complaints from management offices: Water was penetrating through the windows and flashing whenever there was East-facing rain.
- ▶ Armour Restoration was called to provide an inspection of the current state of the window sealant, and flashing. We set up a Bosun chair and conducted several drops around the building to determine the source of the water entry.
- ▶ Our inspection concluded that both the existing Butyl sealant from the glass to metal as well as the perimeter sealant was deteriorated. We also noticed that the weeping holes in the window frames were blocked and / or misaligned. Finally, we reported multiple cracks within the building's mortar lines.

- ▶ We proposed to remove all existing Butyl sealant and replace it with a top-quality product that would offer our client a 20-year warranty.
- ▶ Sand and paint all metal lintels, route and seal all mortar cracks.

- ▶ Armour Restoration removed all of the existing polyurethane sealant and replaced approximately 3,500 linear feet high-grade structural Silicone Sealant.
- ▶ Inspect, clean and/or replace weeping holes and screens.
- ▶ Sanded, primed and painted all metal lintels, routed and sealed masonry cracks.

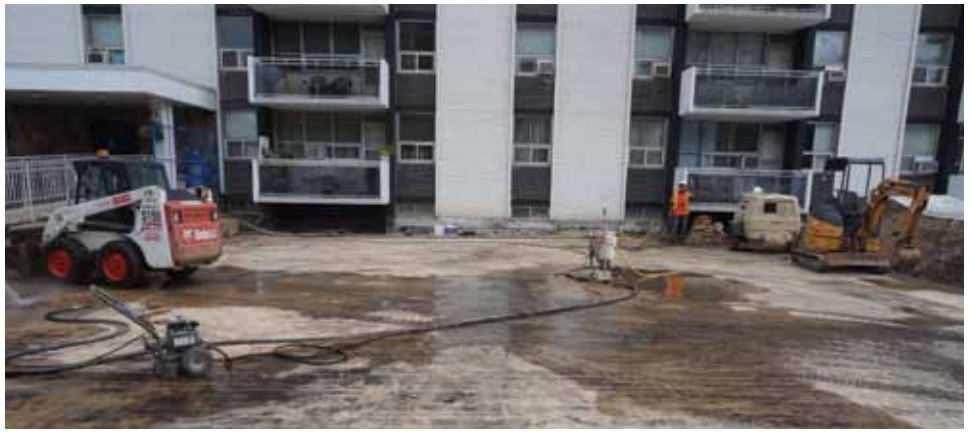
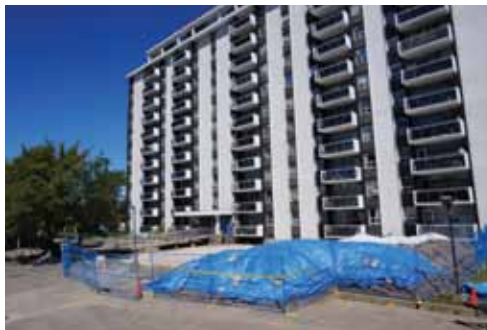
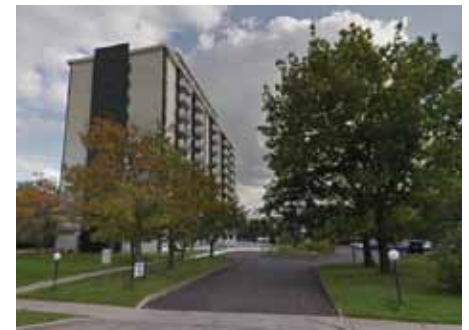
- ▶ Site walk through with a Bid & Tender process for a 12-storey condominium building in Toronto.
- ▶ No previous slab work had been done to the 35-year-old building. The building required a full slab restoration as well as waterproofing. The condo's board of directors stated that there had been leaks in and around the underground garage for years.

- ▶ Remove all existing landscaping, concrete sidewalks, front ramp entrance and asphalt to expose concrete slab. Remove all existing membrane and sand blast area clean.
- ▶ Apply primer and pour hot applied rubber waterproofing layering with reinforcement meshing according to Bakor 790-11 specifications.
- ▶ Reinstate all landscaping, concrete sidewalks, ramp and asphalt.

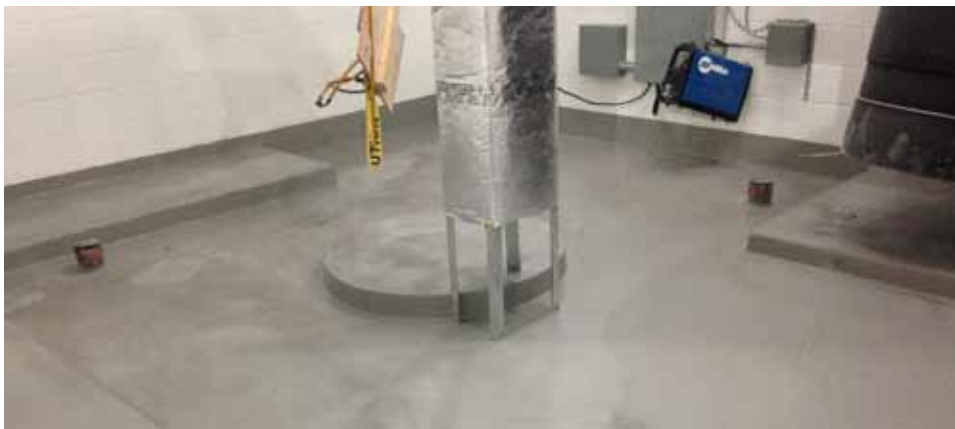
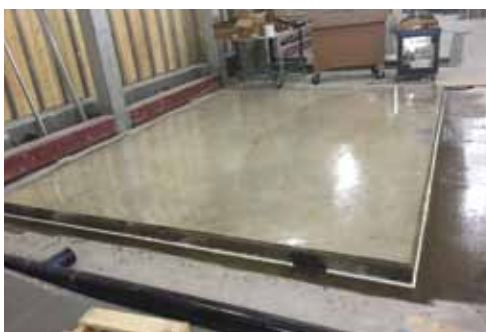
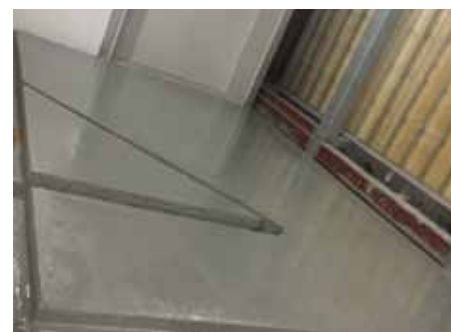
- ▶ New construction for the expansion of three malls in Toronto, North York and Ottawa for new Nordstrom stores.
- ▶ Engineered Scope of Work was to prepare and apply a Urethane floor coating to all mechanical space concrete floors within these three buildings in order to attain a waterproof floor system to protect in case of flooding.

- ▶ Application of the Pecora 800 FC system

- ▶ Armour Restoration was selected based on our expertise in building coatings.
- ▶ Provide and install a Urethane waterproofing system to approximately 15,000 square feet of floor between the three sites.
- ▶ Concrete surface preparation included resurfacing, patching, diamond grinding, and cleaning. Applied a urethane sealant around all cove walls for a 5" upturn and all open junctions and drains.
- ▶ Applied a concrete primer, waterproofing base coat, and traffic top coat finished with a broadcasting of Silica aggregate for a non-slip finish.

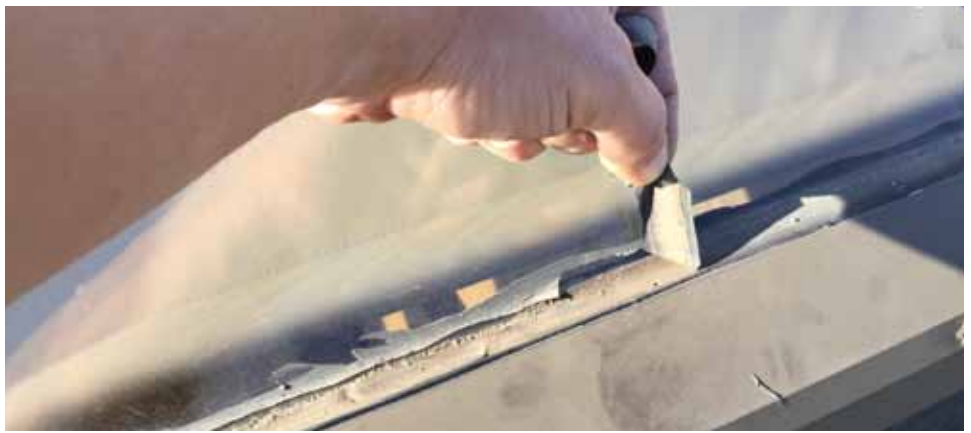
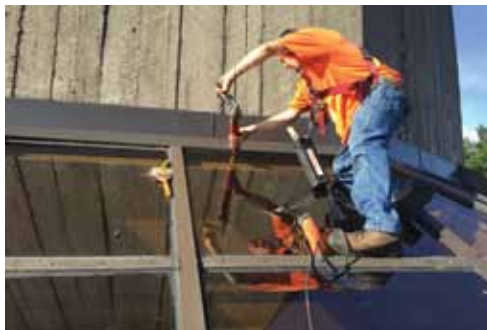
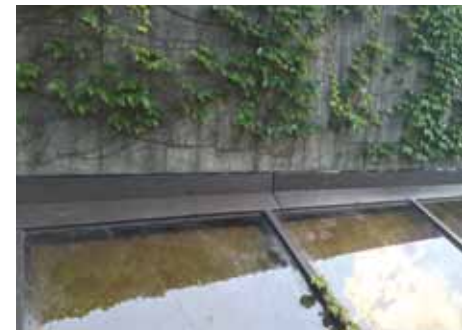
- ▶ U of T maintenance department receiving complaints from staff offices, which were experiencing leaks coming through the windows and flashing of their "S" building. Armour Restoration was called to inspect and report on the current state of the window sealants.
- ▶ During our inspection, we found that the existing sealant was deteriorated, which U of T found "odd" given that maintenance logs established that the sealant was replaced only a few years earlier.
- ▶ Armour found many areas of inconsistent sealant and determined the previous contractor had incorrectly applied a thin new layer of sealant over the old, failed sealant. Although the sealant appeared new, it did not fix the leaking issues and was a poor, "band aid" solution.

- ▶ Armour was selected to remove all existing sealant and replace with a top-quality product that would offer our client a 20-year warranty.

- ▶ Access was provided by a 60-ft. boom lift.
- ▶ Armour Restoration removed the two layers of existing polyurethane sealant in its entirety and replaced approximately 5,000 linear feet of high-grade structural silicone sealant.
